REFURBISHMENTS

Sugg Lambeth

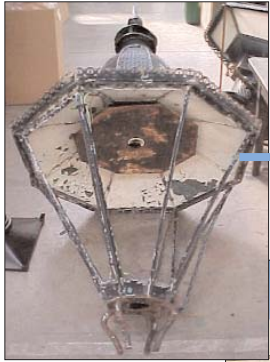
The picture left shows the lantern as it was returned, with damage to the frame and glazing ribs, also the frog had been damaged during its removal from the column. The internal tray had rusted away and the glazing had been broken over a period of time. The new carrying frame would have to be made to carry the weight of the lantern as the frog had been cut from the original spigot. The frame was fixed to the widest part of the lantern and then to a plate that bolted to the top of the column thereby supporting the frog and lantern. This was designed to follow the glazing profile and minimise the effect of the additional framing structure as it was fitted with four frame bars covering every other rib on the eight sided lantern.

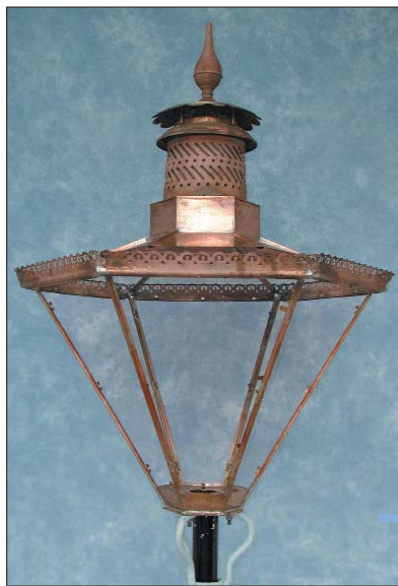
The refurbished Lambeth Lantern with clear polycarbonate glazing in the lower section and opal polycarbonate in the top section.
